SUBJ: Flight Controls; Cable Terminals Used on 14 CFR Part 23 and CAR Part 3 Airplanes with Mechanical Flight Control Cables

SAIB: CE-19-13
Date: July 2, 2019

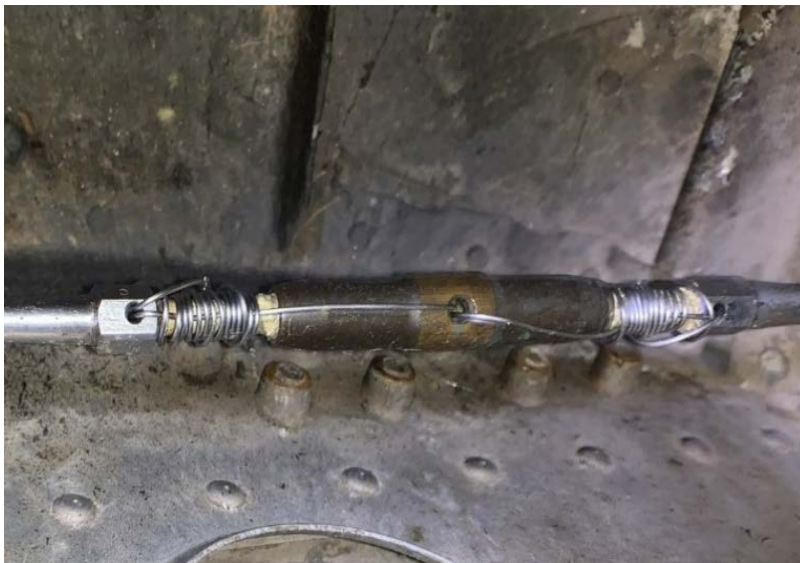
Depending on whether safety wire or a safety clip is used to secure the turnbuckle, any corrosion such as this may be hidden from view by the safety wire, which needs to be removed in order to perform an adequate inspection. The following photograph shows a typical safety wire configuration.

- a. If safety wire is installed such as to prevent examination of the fitting surface, the safety wire must be removed.
Caution: Care should be taken to avoid any adjustment of the turnbuckle relative to the fittings. Otherwise, re-rigging of the affected flight control cables per the manufacturer's instructions should be done before further flight.
